## Ex-situ X-ray computed tomography, tension clamp and in-situ transilluminated white light imaging data of non-crimp fabric based fibre composite under fatigue loading

# Ex-situ X-ray computed tomography, tension clamp and in-situ transilluminated white light imaging data of non-crimp fabric based fibre composite under fatigue loading

Kristine M. Jespersen<sup>a,\*</sup>, Jens A. Glud<sup>b</sup>, Jens Zangenberg<sup>c</sup>,  
Atsushi Hosoi<sup>d</sup>, Hiroyuki Kawada<sup>d</sup>, Lars P. Mikkelsen<sup>a,\*</sup>

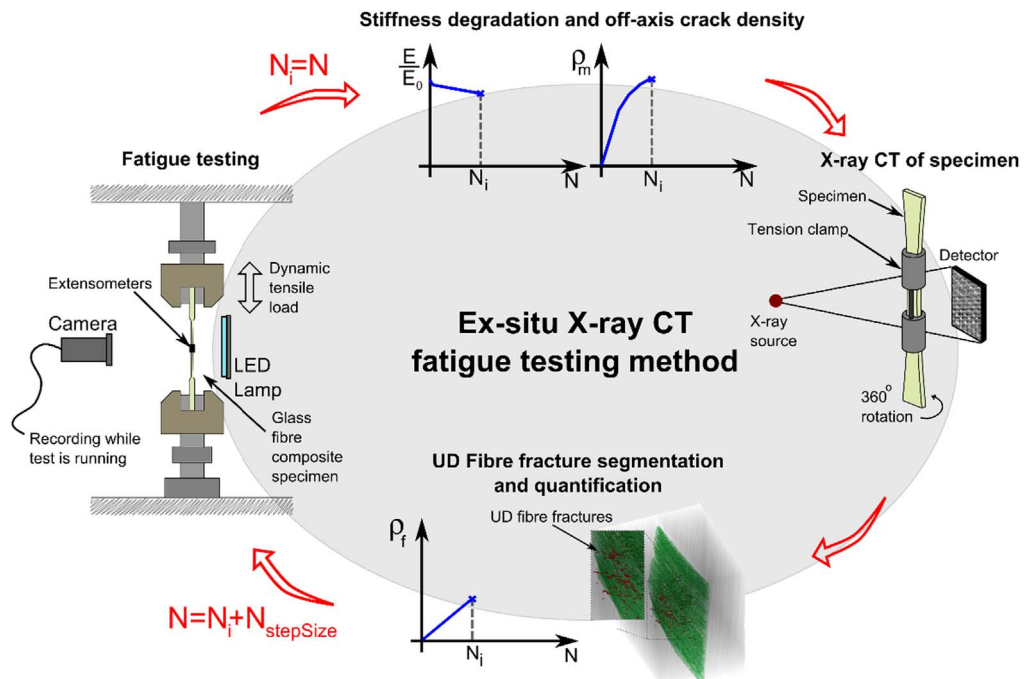
**Fig. 1.** Overall idea behind ex-situ X-ray CT fatigue testing approach supplemented by TWLI and tension clamp.

The methods used to obtain the data provided with this paper are based on the idea shown in Fig. 1, which shows the general principle of the ex-situ X-ray CT fatigue testing method. To overcome some of the challenges of X-ray CT, TWLI and tension clamp experiments were also carried out as supplements. The TWLI was carried out during the fatigue test as illustrated by the camera and LED lamp in the left-hand image of Fig. 1. The tension clamp data provided with this paper is not included in the ex-situ testing loop this time, however it could be included in future work as illustrated in the left-hand image of Fig. 1 to improve the crack visibility. The below sections outline the specifics of the individual testing methods.

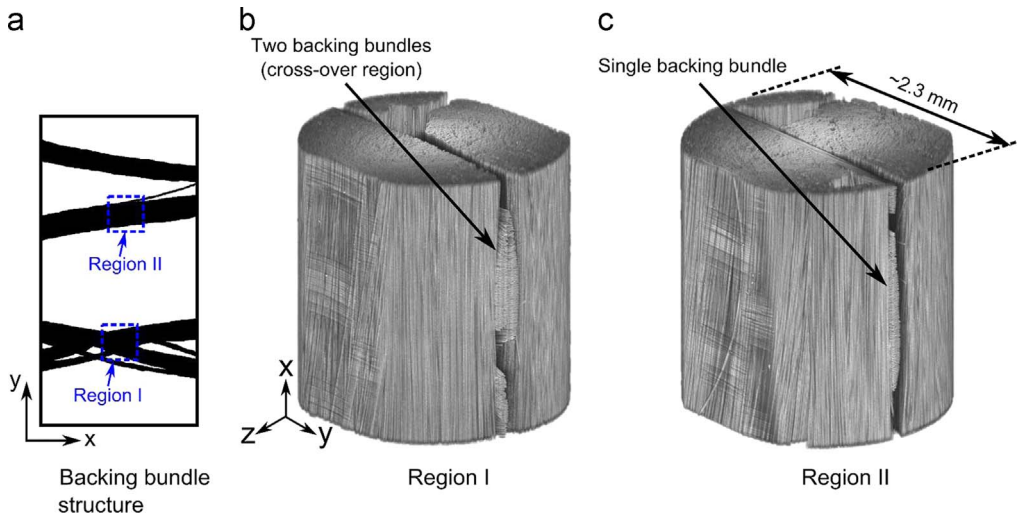
**Fig. 2.** The approximate locations of the two regions considered by X-ray CT in specimen EPS06-1 are shown on top of the bundle structure in (a) and the 3D volumes obtained by X-ray CT are shown in (b) and (c) for region I and II, respectively.

High resolution X-ray CT with a pixel size of  $2.25 \mu\text{m}$  was used for both the ex-situ study and the tension clamp experiments. For the ex-situ experiments, the source-to-sample and detector-to-sample distances were 20 mm and 40 mm respectively, and the exposure time was 2.5 s. Two regions were considered ex-situ in the specimen (EPS06-1 in Table 1) as illustrated by region I and II in Fig. 2. Region I was scanned before any testing had been done to the specimen at each of the interruption points (100,000, 150,000, 200,000, and 500,000 cycles). Region II was only scanned at the last three interruption points (150,000, 200,000, and 500,000 cycles). Fig. 3 shows an example of a 2D slice view of region II for the three interruption points. This results in 8 datasets for the ex-situ study. For clarity the data for the tension clamp have “ex-situ\_” in front of the file name. The detailed scan settings are also provided as “ex-situ\_info1.png” and “ex-situ\_info1.png”.

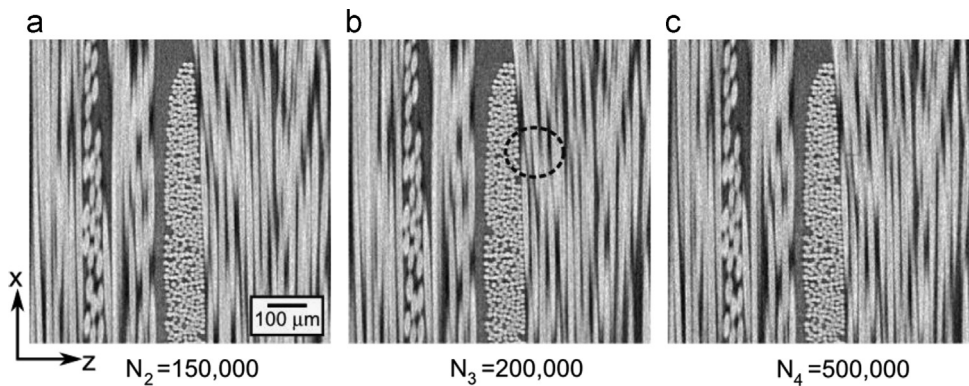
**Fig. 3.** Example of 2D slice view of region II during ex-situ fatigue test.
